FIELD SERVICE BULLETIN

FILE: 14-UI BULLETIN 17

SUBJECT: Improper Engine Block Heater (Option K05) Usage – Continuous Power

Subject: Improper Engine Block Heater (Option K05) Usage - Continuous Power

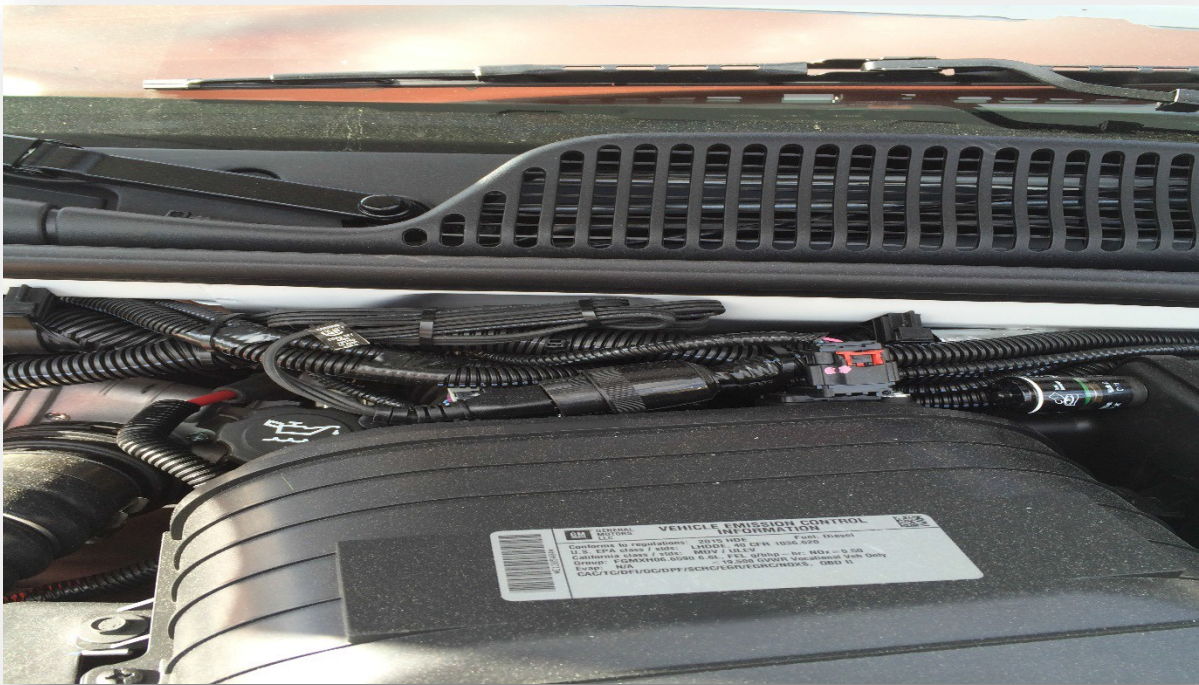
Photo 1

Step 1) Raise the hood and locate the 115 volt male and female electrical plugs Reference Photo #1

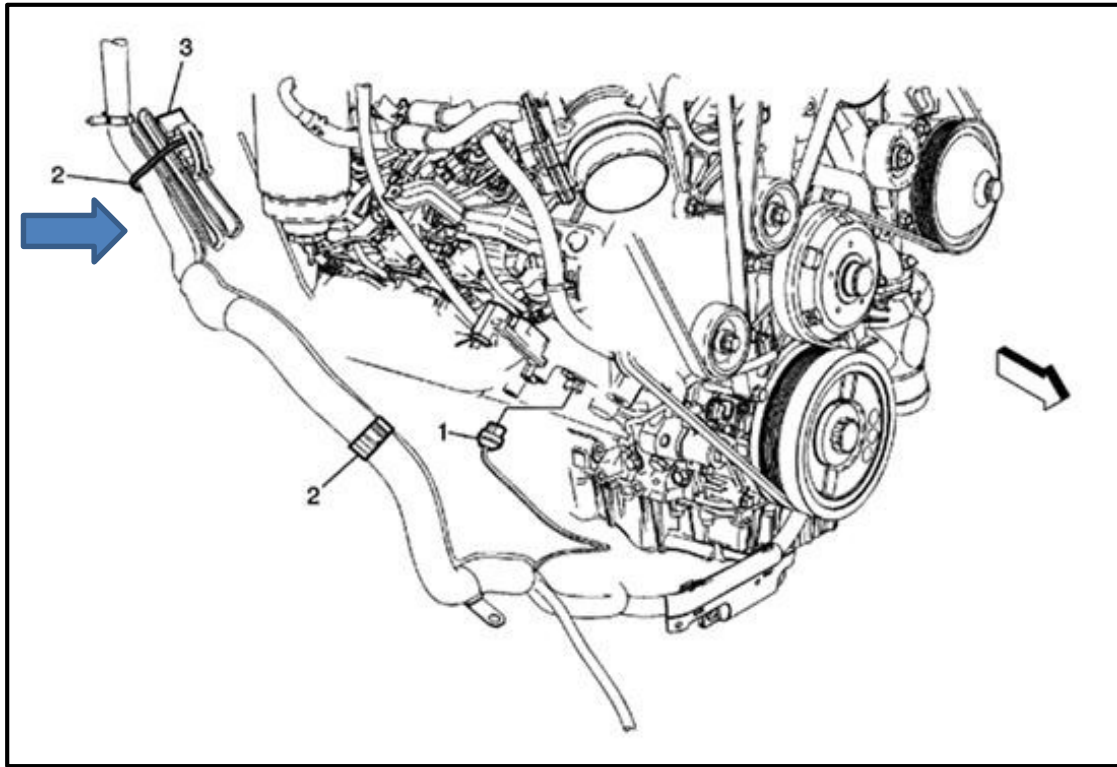
As shipped from GM, the available Engine Block Heater Cord is furled up and attached under hood as illustrated in Figure 1 (item #2 & #3).

Fleet customers, dealers, and secondary vehicle manufacturers/upfitters are reminded that the Regular Production Option (RPO) K05 Block Heater is to be used for Intermittent Cold Ambient starts when the outside temperature is between -18 degrees C (-0 degrees F) and -29 degrees C (-20 degree F) – not to be continuously plugged into an "A/C" source.
